TECHNICAL REPORT GL-79-20

INVESTIGATION OF BEACH SAND TRAFFICABILITY ENHANCEMENT USING SAND-GRID CONFINEMENT AND MEMBRANE REINFORCEMENT CONCEPTS

SAND TEST SECTIONS I AND 2

November 1979

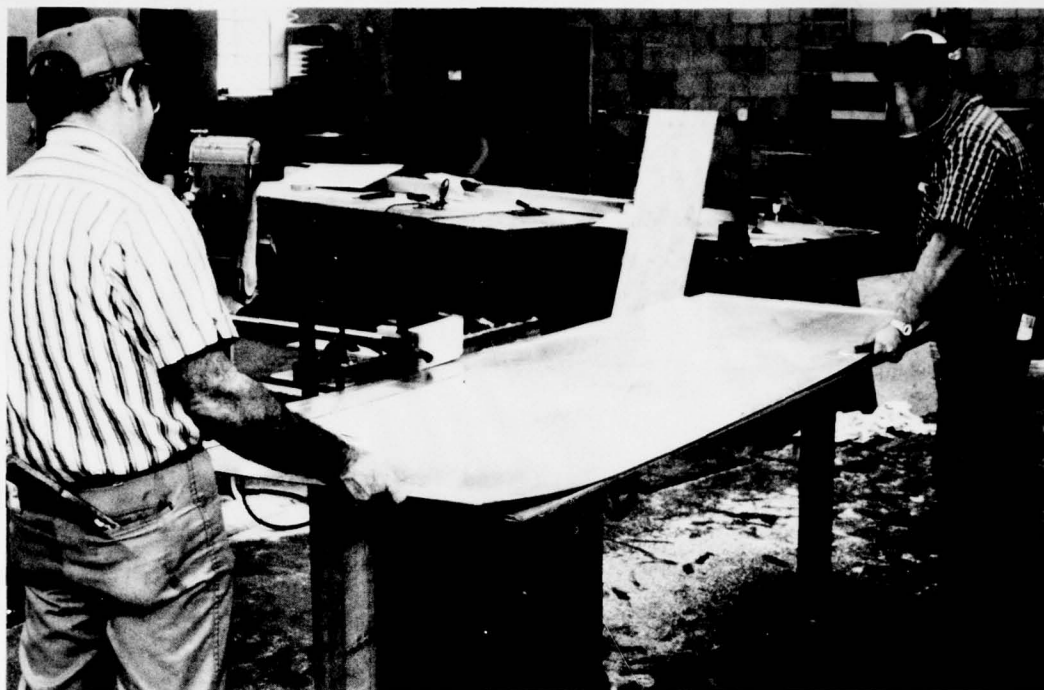
Figure 1. Cutting grid panels from stock sheets of aluminum

10. The aluminum grids used were fabricated at the WES from stock aluminum sheets (3 by 8 ft) 0.025 in. thick. First, several sheets of aluminum were stacked and sawed into 8-ft-long grid panels, each having a width equal to the desired grid thickness (either 6 or 8 in.), as shown in Figure 1. Next, the grid panels were stacked and held together by vise grips, while slots were sawed halfway down the panels at desired grid cell size intervals (Figure 2). Four-foot-long grid panels with matching slots were also made using the same procedure. The 8-ft-long panels were placed in a wood jig that aligned the panel slots such that inverted 4-ft-long panels could be inserted to form a 4- by 8-ft grid section having the desired cell size. Filament-reinforced adhesive tape was used to hold the panels together such that the completed grid sections could be folded flat for storage and handling or opened for usage without falling apart. Figure 3 shows grid sections opened for field placement along with a supply of folded grid sections (upper part

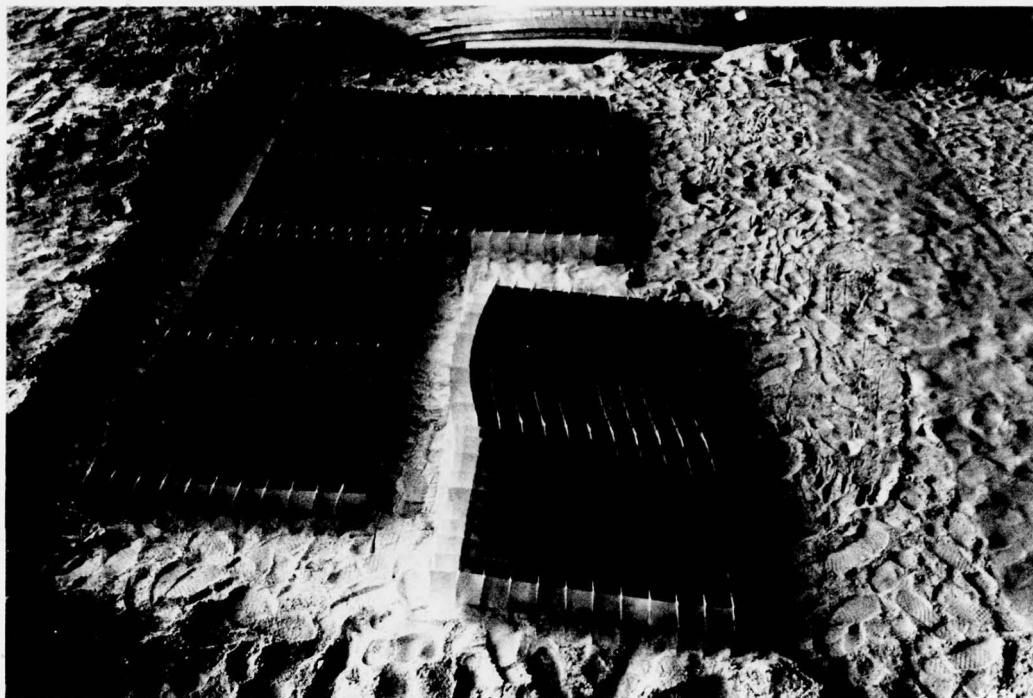
Figure 3. Folded and opened sections of grid

of Figure 3). Material and labor costs for the completed grids were approximately \$0.90 per sq ft of opened surface area for grids having a cell size of 6 in. and a thickness of 6 in.

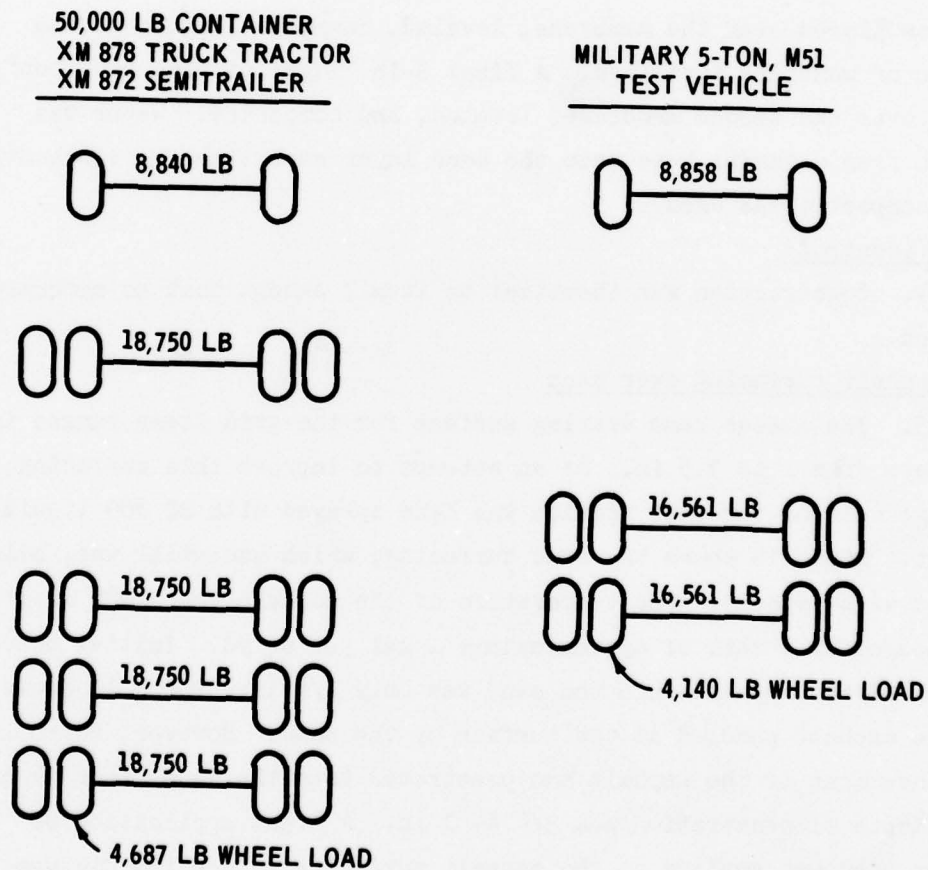
Figure 4. Tire configuration for the XM 878 truck tractor with XM 872 semitrailer and the military 5-ton, M51, test vehicle

26. Test traffic was applied during May and June of 1978. Traffic was applied using the military 5-ton, M51, tandem-axle dump truck shown in Photo 16. A tire configuration for the XM 878 yard truck tractor and XM 872 semitrailer loaded with a 50,000-lb container and for the test vehicle is shown in Figure 4. Since the test vehicle had a lighter

wheel load and fewer wheels than the XM 878-XM 872 combination, it would require approximately 3.3 passes of the test vehicle to equal one pass of a loaded container vehicle. The 11x20, 12-ply tires were inflated to the recommended military highway tire pressure of 70 psi. The test section was trafficked as a one-lane road. The truck was driven forward and then in reverse over the entire length of the test section.

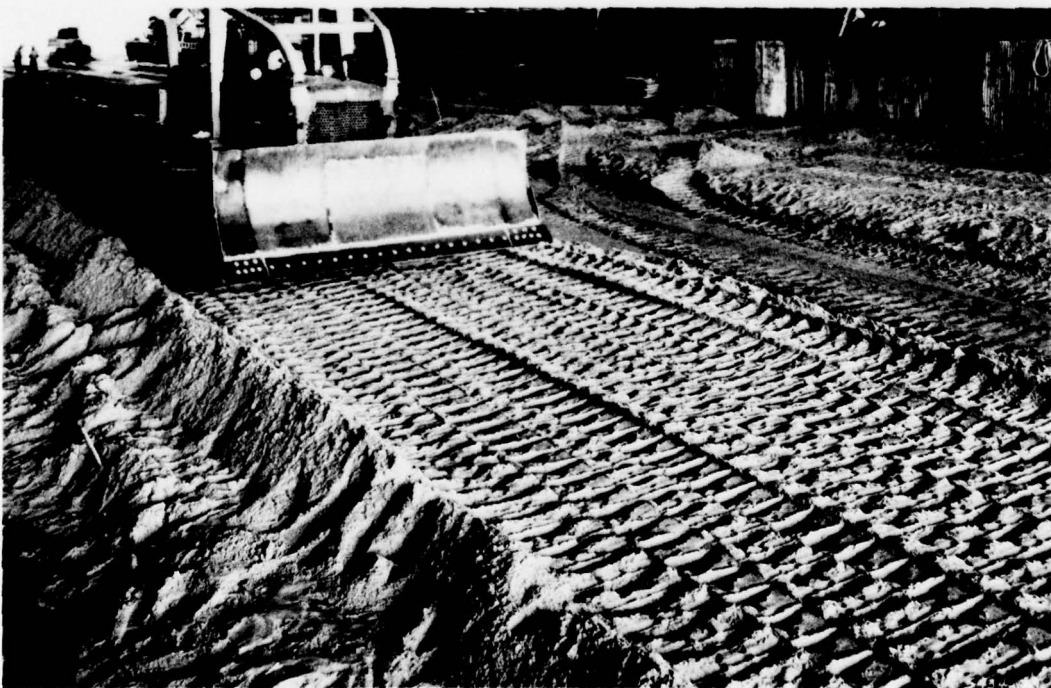
Photo 8. Tractor smoothing and compacting sand-grid layer, test section 1

20. After the grids were filled with sand, the tractor walked the entire surface as shown in Photo 8. The excess sand layer protected the grids as the tractor compacted the sand in the grid cells. Next, the towed-type roller (25,000-lb load on four tires with 50-psi tire pressure) was used over the grids (Photo 9). It was found that the roller could be used to compact the sand in the grid cells with no apparent damage to the grids. Some slight rutting did occur where there was an excess sand layer. A motor grader was used to obtain a smooth sand surface over the grids.

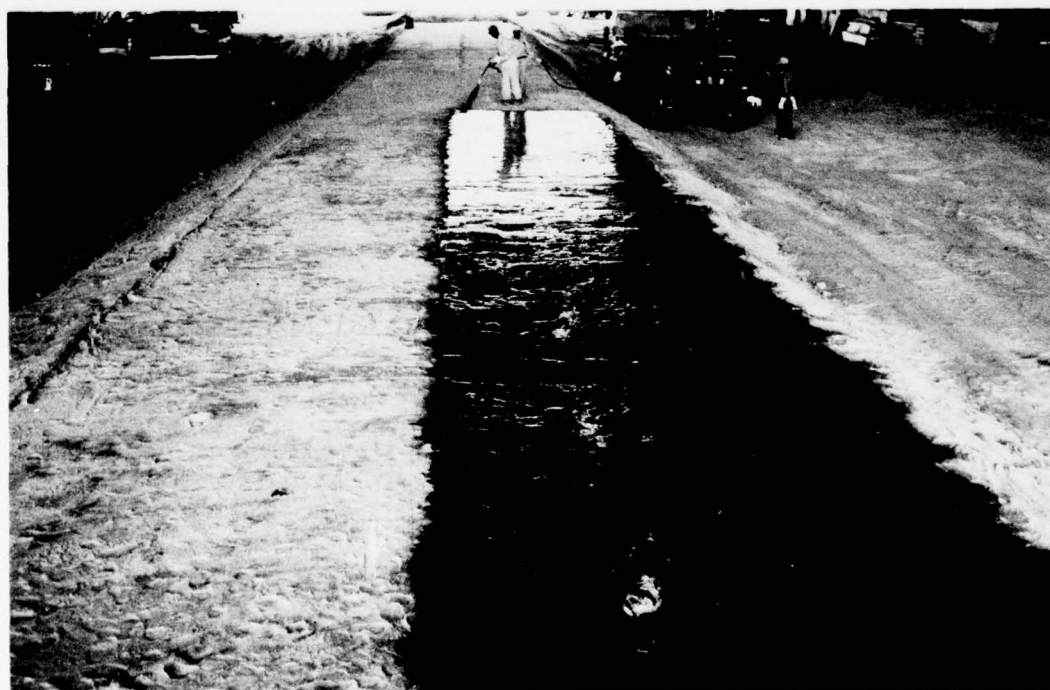
Photo 14. Spraying RC 800 liquid asphalt on sand surfacing,
east half of test section, test section 1

25. The excess sand wearing surface for the grid items ranged in thickness from 1 to 3.5 in. As an attempt to improve this surfacing, the east half of the test section was hand sprayed with RC 800 liquid asphalt. Photo 14 shows the sand surfacing, which was still wet, being sprayed with asphalt. The temperature of the asphalt was 220°F as it was sprayed at a rate of approximately 1 gal per sq yd. Initial penetration of the asphalt into the sand was only 1/4 in. Photo 14 shows how the asphalt puddled at the surface of the sand. However, Photo 15 shows how most of the asphalt had penetrated into the sand after 24 hr. Final depth of penetration was 3/4 to 1 in. A light application of blotter sand was applied to the asphalt surfacing before traffic was applied. Grade RC 250 liquid asphalt would probably have penetrated

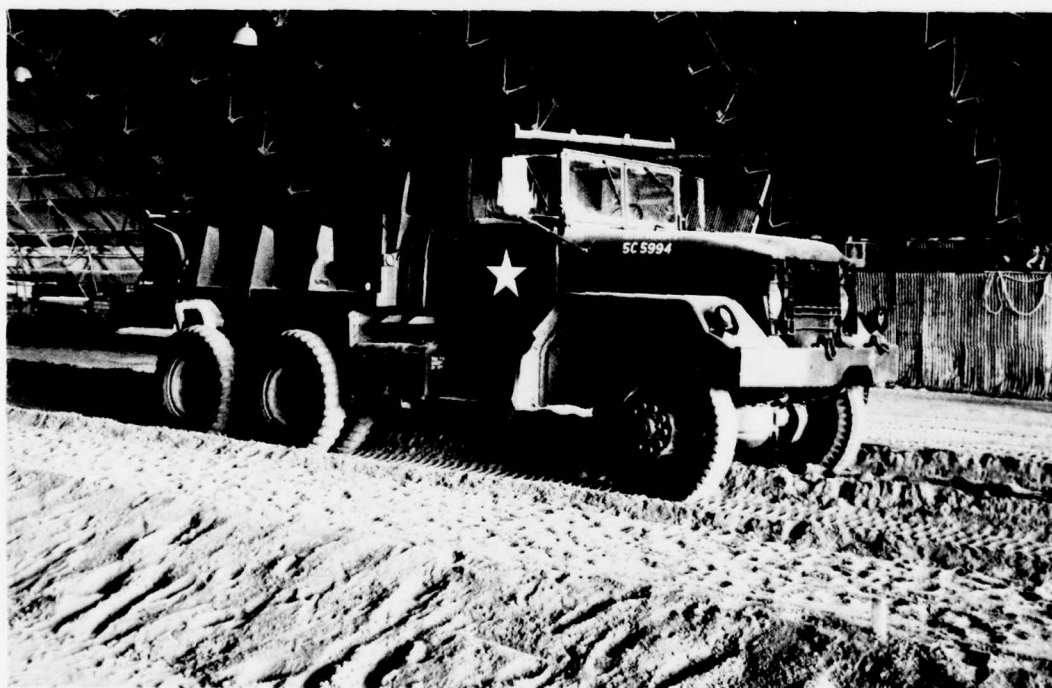
Photo 16. Military 5-ton, M51, test vehicle,
test section 1

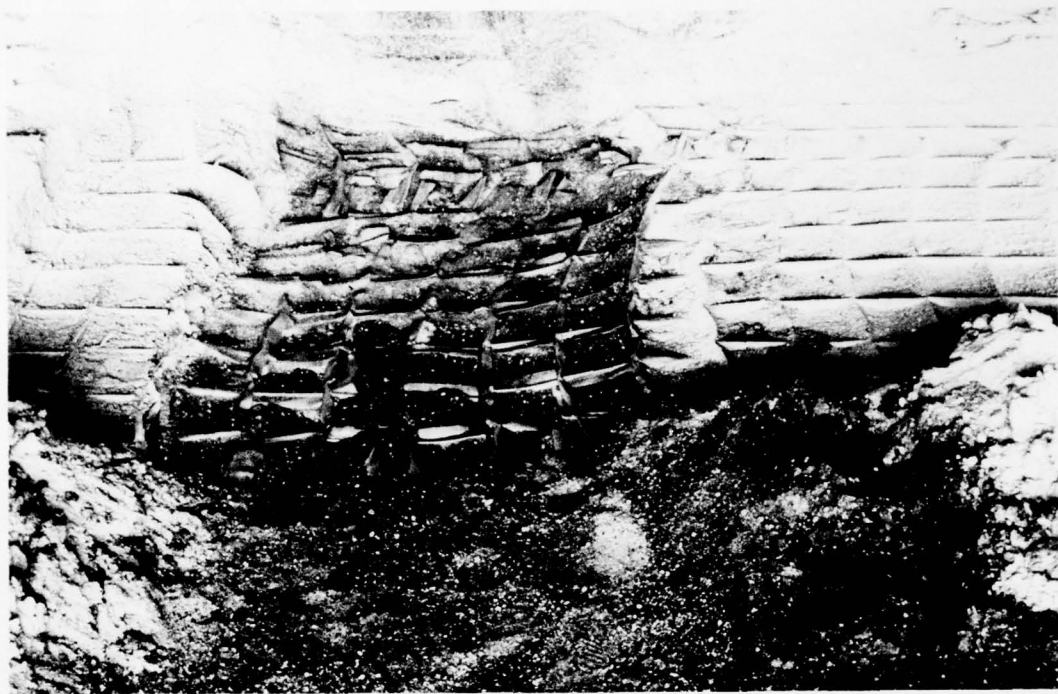
Photo 21. East wheel path grid surface after 2000 passes,
item 2, test section 1

rut depth had increased to 11.8 in., and a piece of grid was observed lying flat in the wheel path. Test traffic on the east wheel path was concluded after 2000 passes. Photo 21 shows the east wheel path with the surfacing removed after 2000 passes. The tops of the grid cells were bent by traffic, and sand-asphalt was embedded within the bent cells. The average minimum thickness in the east wheel path was 3.3 in. A trench cut through the sand-grid layer revealed that the east subgrade surface had rutted 2.0 in.

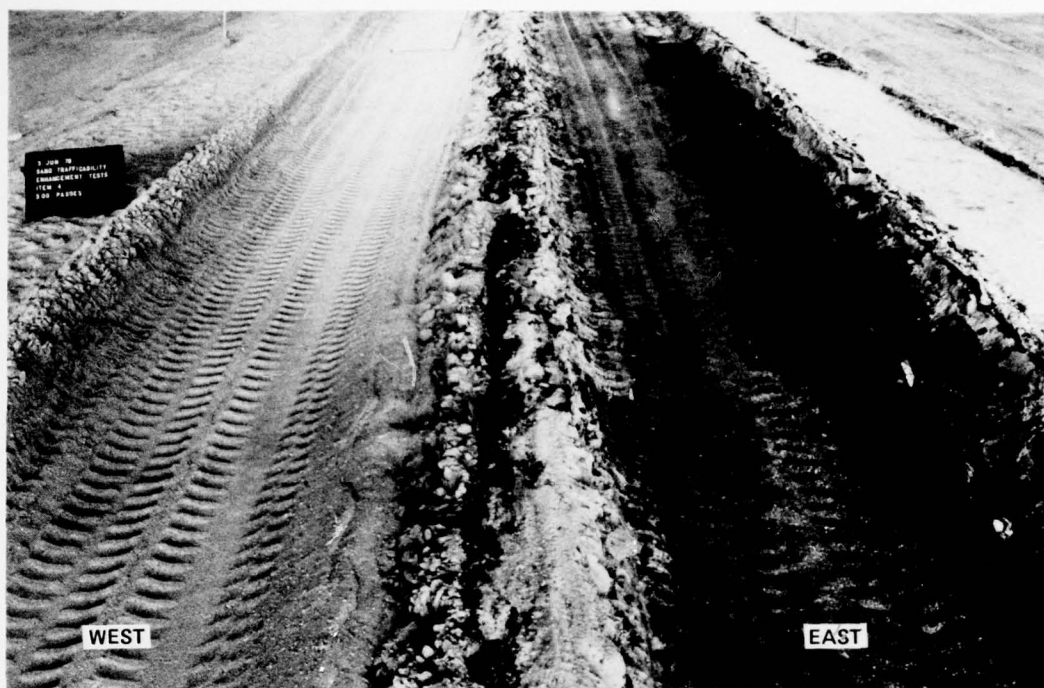
Photo 23. Item 4 after 500 passes, test section 1

rut or noticeable grid disintegration developed. After 500 passes of traffic (Photo 23), both wheel paths had ruts approximately 9 in. deep. However, additional rutting developed very slow, and rut depths after 4850 passes of traffic were 10.1 and 11.0 in. in the east and west wheel paths, respectively. Photo 24 shows the condition of the sand-grid layer after 4850 passes. The average minimum grid thickness was approximately 6 in. in each wheel path. The rut depth at the subgrade surface was 1.5 and 1.3 in. for the east and west wheel paths, respectively. Plate 6 shows typical cross-section data for the item.

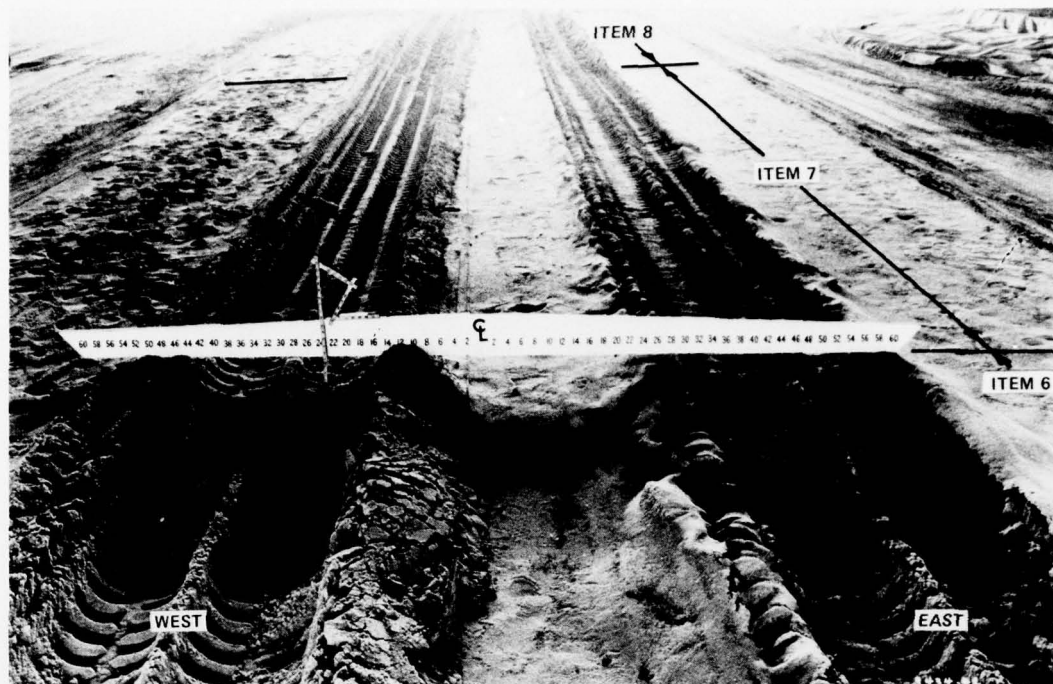
Photo 25. Items 6-8 after five passes, test section 1

38. The trafficability enhancement potential from buried membranes was demonstrated early during traffic tests on this item. Photo 25 shows items 7 and 8 and a portion of item 6 after five passes of the truck. Notice the increased lateral movement of material (and thus deeper ruts) in item 6. Also, traction problems that occurred in item 8 did not occur in item 7. Photo 26 shows the item after 100 passes of traffic with rut depths of 6.4 and 6.6 in. in the east and west wheel paths, respectively. Notice how landing mat runners were used to repair failed items 6 and 8 so that traffic could continue on item 7. Photo 27 shows the item after 1000 passes of traffic. Rut depths were 9.3 and 10.1 in. in the east and west wheel paths, respectively. The center line of the truck traffic gradually shifted west as traffic was applied. By 1000 passes, the total westward shift was approximately 24 in. This westward wander of the traffic caused the top layer of membrane to pull

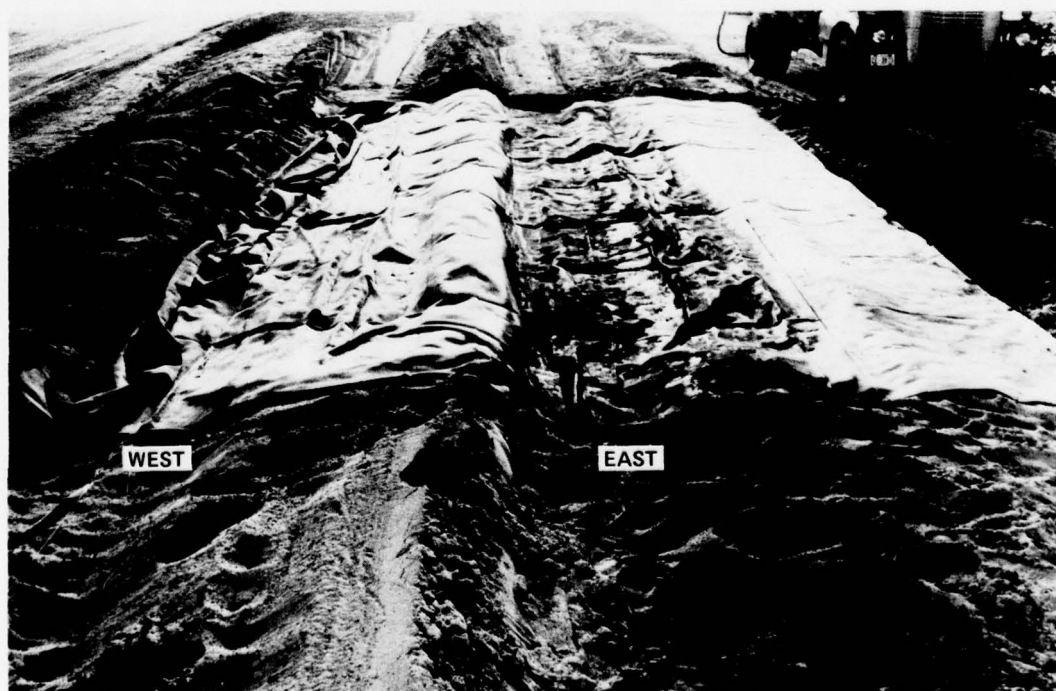
Photo 28. Top layer of membrane after 1000 passes,
item 7, test section 1

in from the west edge. By 1000 passes, the total west edge of the top membrane was lying in the west wheel path. Traffic was concluded at this time so that the condition and position of the membranes could be determined. Photos 28 and 29 show the top and bottom membranes, respectively, as cover sand was removed after 1000 passes of traffic. Both membranes were in excellent condition. Typical cross-section data are shown in Plate 9.

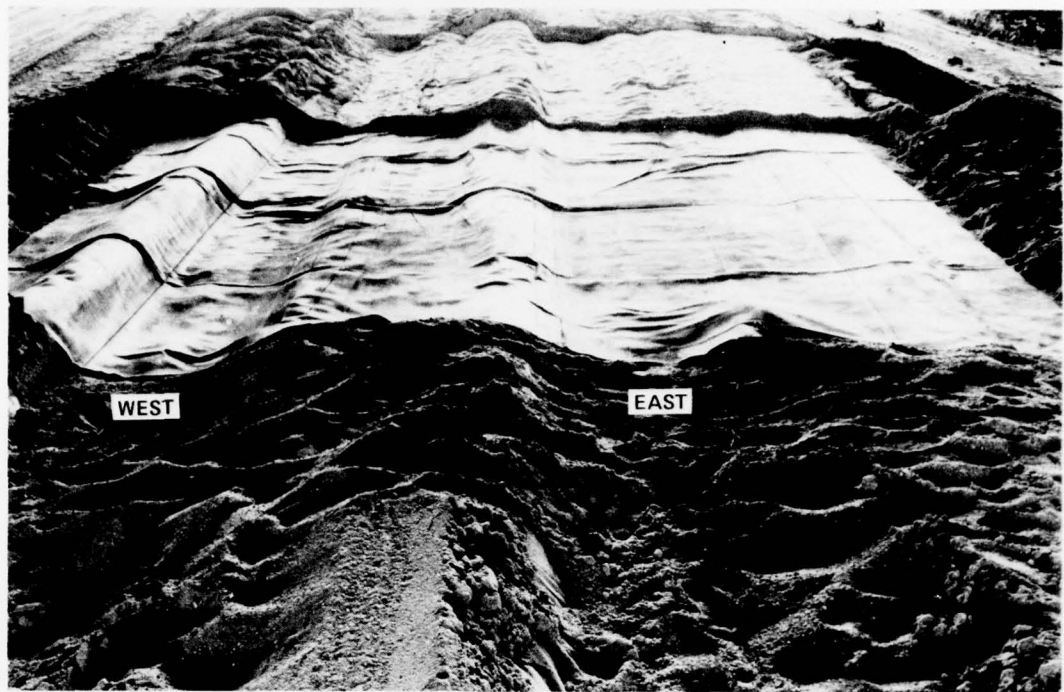
Photo 29. Bottom membrane and cover sand after 1000 passes,
item 7, test section 1

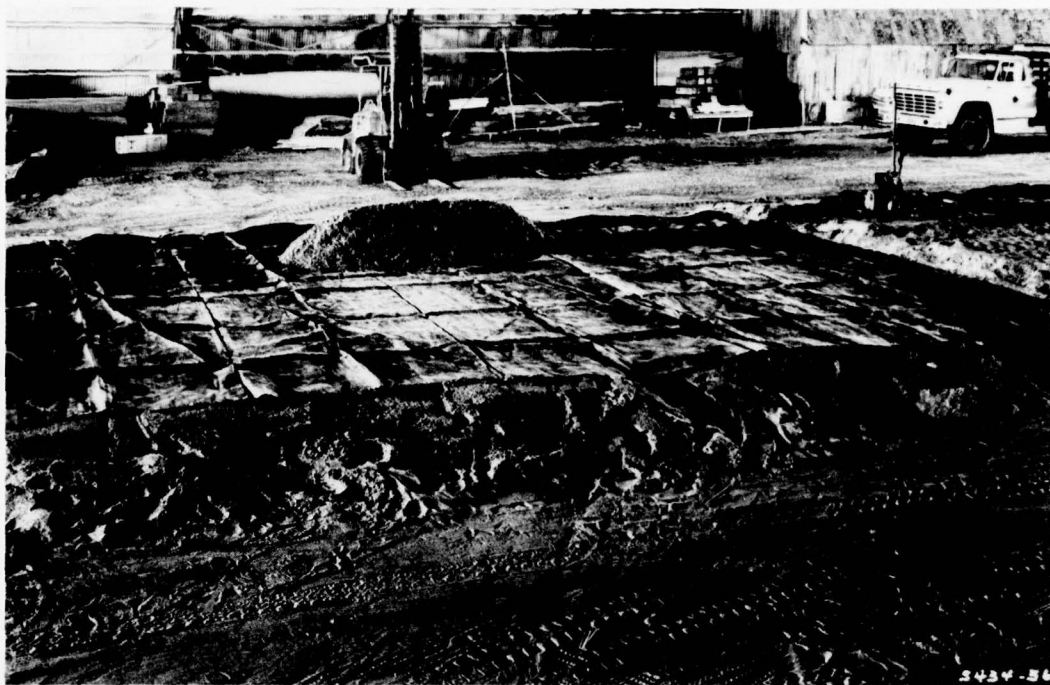
Photo 31. Construction of item 6A, test section 1

40. After 100 passes of traffic on the test section, item 6A was installed to replace failed item 6. Item 6A consisted of one layer of T-17 membrane buried 4 in. in the sand. Photo 31 shows construction of this item using a 20- by 30-ft section of membrane. A 4-in. layer of cover sand and 20-ft width of membrane were chosen to help anchor the membrane along the sides of the wheel paths. Photo 32 shows item 6A prior to traffic.

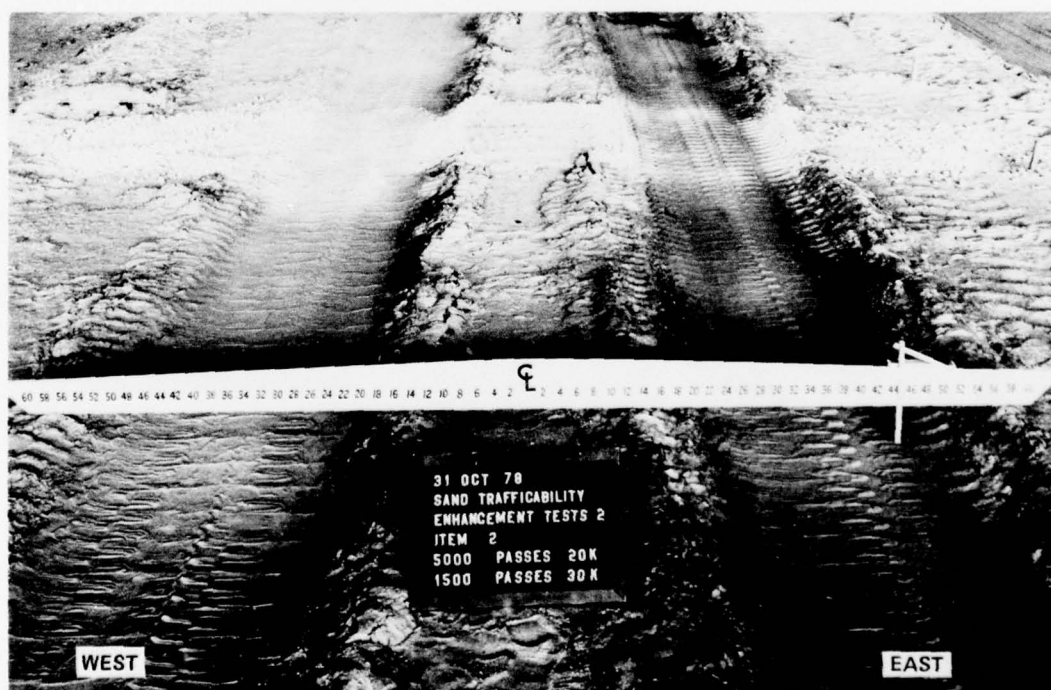
Photo 50. Item 2 after 6500 passes, test section 2

61. Photo 50 shows the item after an additional 1500 passes of traffic were applied at the increased truck load. Average rut depths were 4.4 and 3.4 in. in the east and west wheel paths, respectively. The permanent surface depression was 2.4 and 2.2 in. in the east and west wheel paths, respectively. The sand-grid layer was in excellent condition and could have handled a substantial amount of additional traffic.

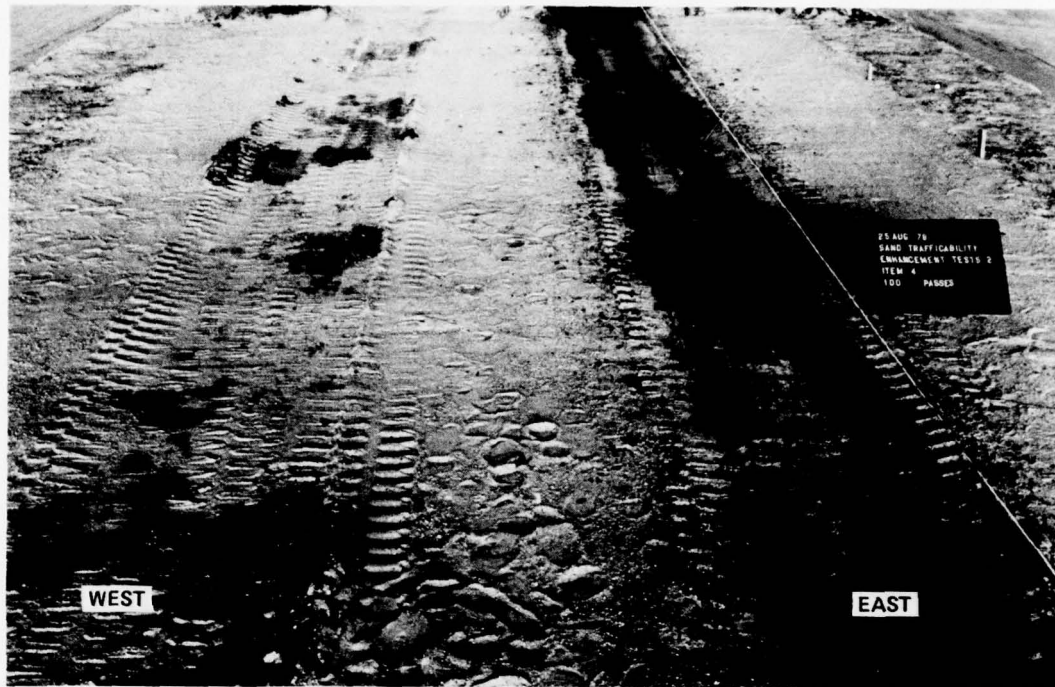
Photo 55. Item 4 after 100 passes, test section 2

65. Traffic on this item showed that grid thickness and grid-sand type are related to performance. After 100 passes (Photo 55), rut depths averaged 0.6 and 0.8 in. in the east and west wheel paths, respectively. After 3000 passes (Photo 56), rut depths averaged 5.9 and 4.1 in. in the east and west wheel paths, respectively. The permanent surface depression in the east wheel path was 2.4 in. Pieces of grid were emerging from the edges of the wheel path. The permanent surface depression in the west wheel path was 2.0 in., and the sand-grid layer was still in good condition.

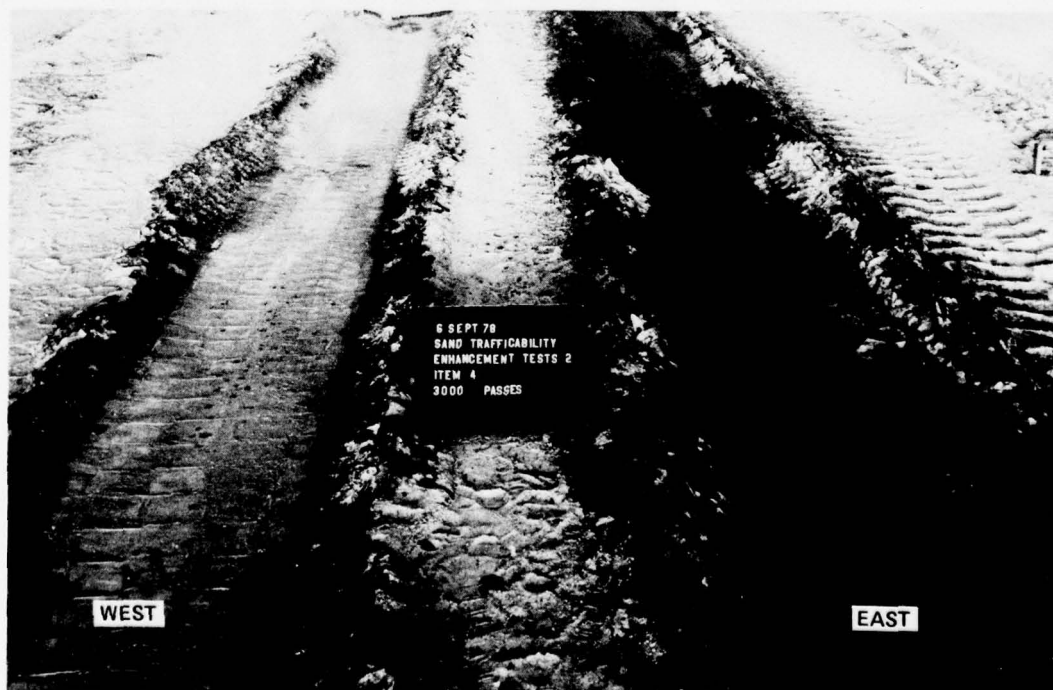
Photo 56. Item 4 after 3000 passes, test section 2

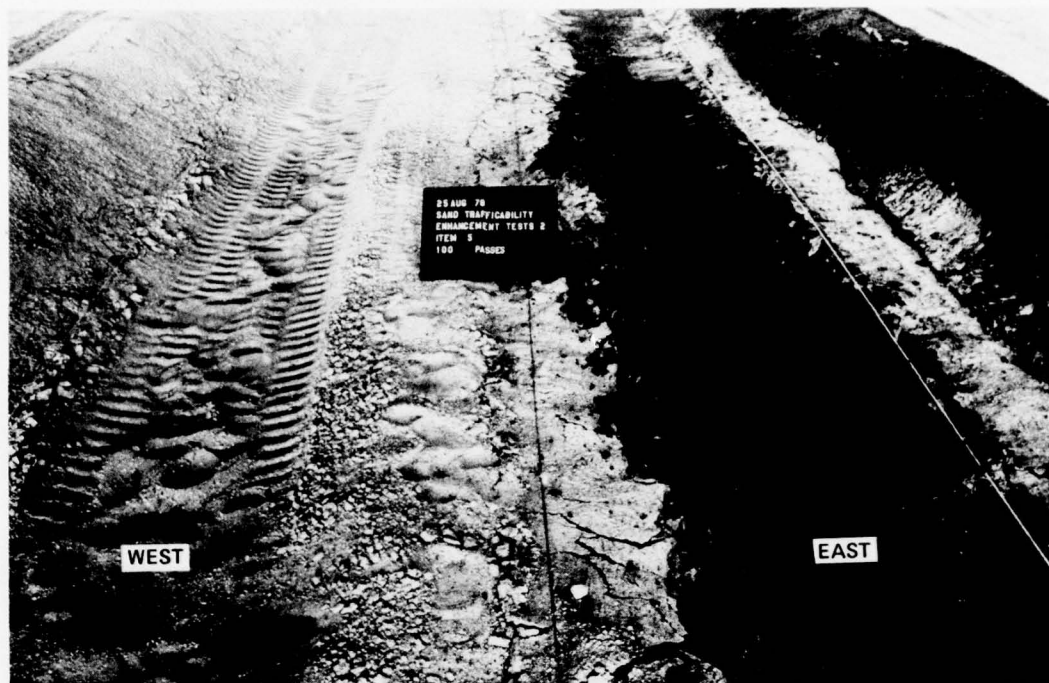
Photo 59. Item 5 after 100 passes, test section 2

68. Performance of this membrane item was a significant improvement over the two membrane items tested in test section 1. Photo 59 shows the item after 100 passes. The rut depths averaged approximately 5.5 in. in each wheel path. Photo 60 shows the item after 3500 passes of traffic. Spot failures had developed in the top layer of membrane in each wheel path. The membrane failures were a result of abrasive wear from the sand surfacing and truck tires. The average rut depths had increased very slowly and were 7.4 and 7.2 in. in the east and west wheel paths, respectively. Photo 61 shows a sectional view of the item after the surfacing sand and top membrane were removed at 3500 passes. Average rut depth measurements on the bottom membrane were 2.2 and 2.5 in. for the east and west wheel paths, respectively. The timber runners along each side of the item were successful in preventing the membranes from pulling in toward the wheel paths. Typical cross-section data are shown in Plate 21.

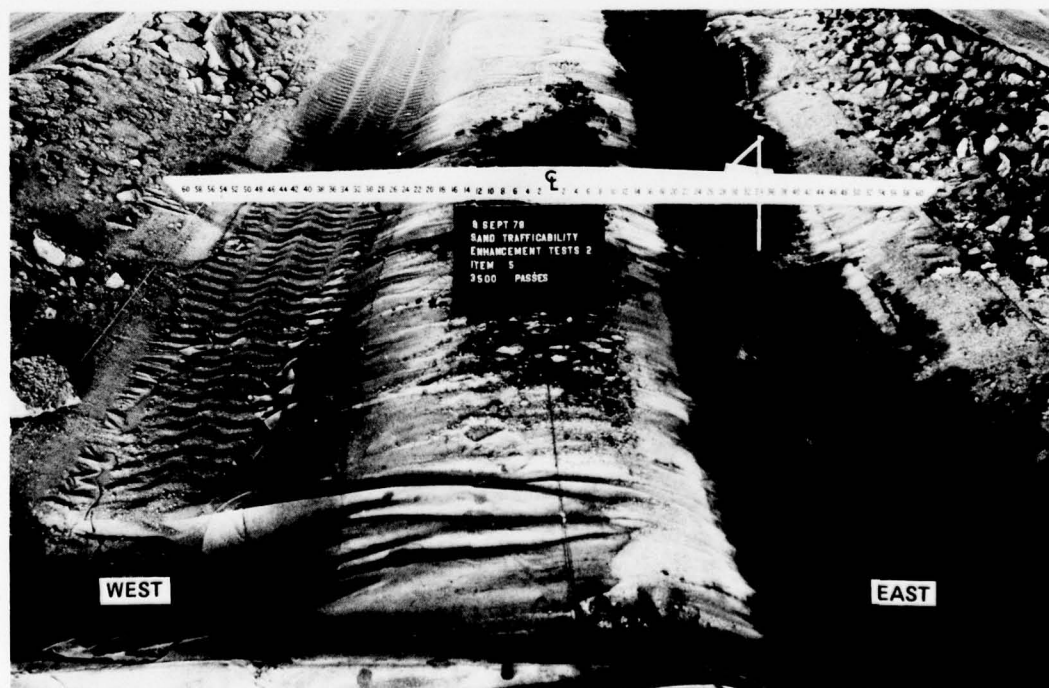
Photo 60. Item 5 after 3500 passes, test section 2

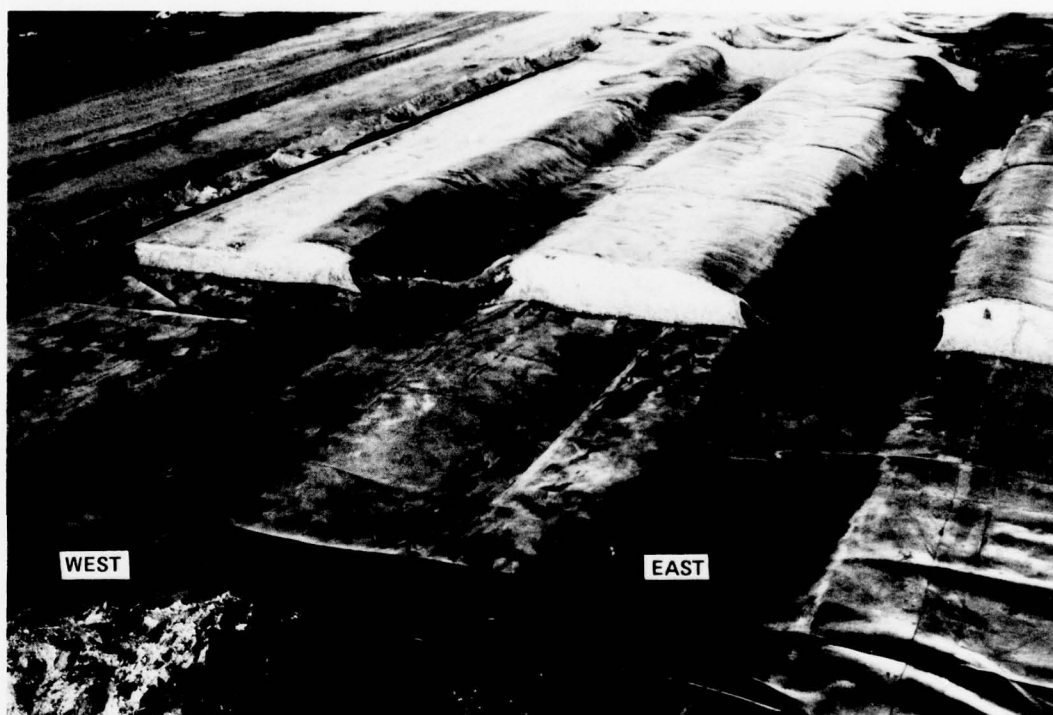
Photo 61. Section view of item 5 after surfacing sand and top membrane were removed at 3500 passes, test section 2

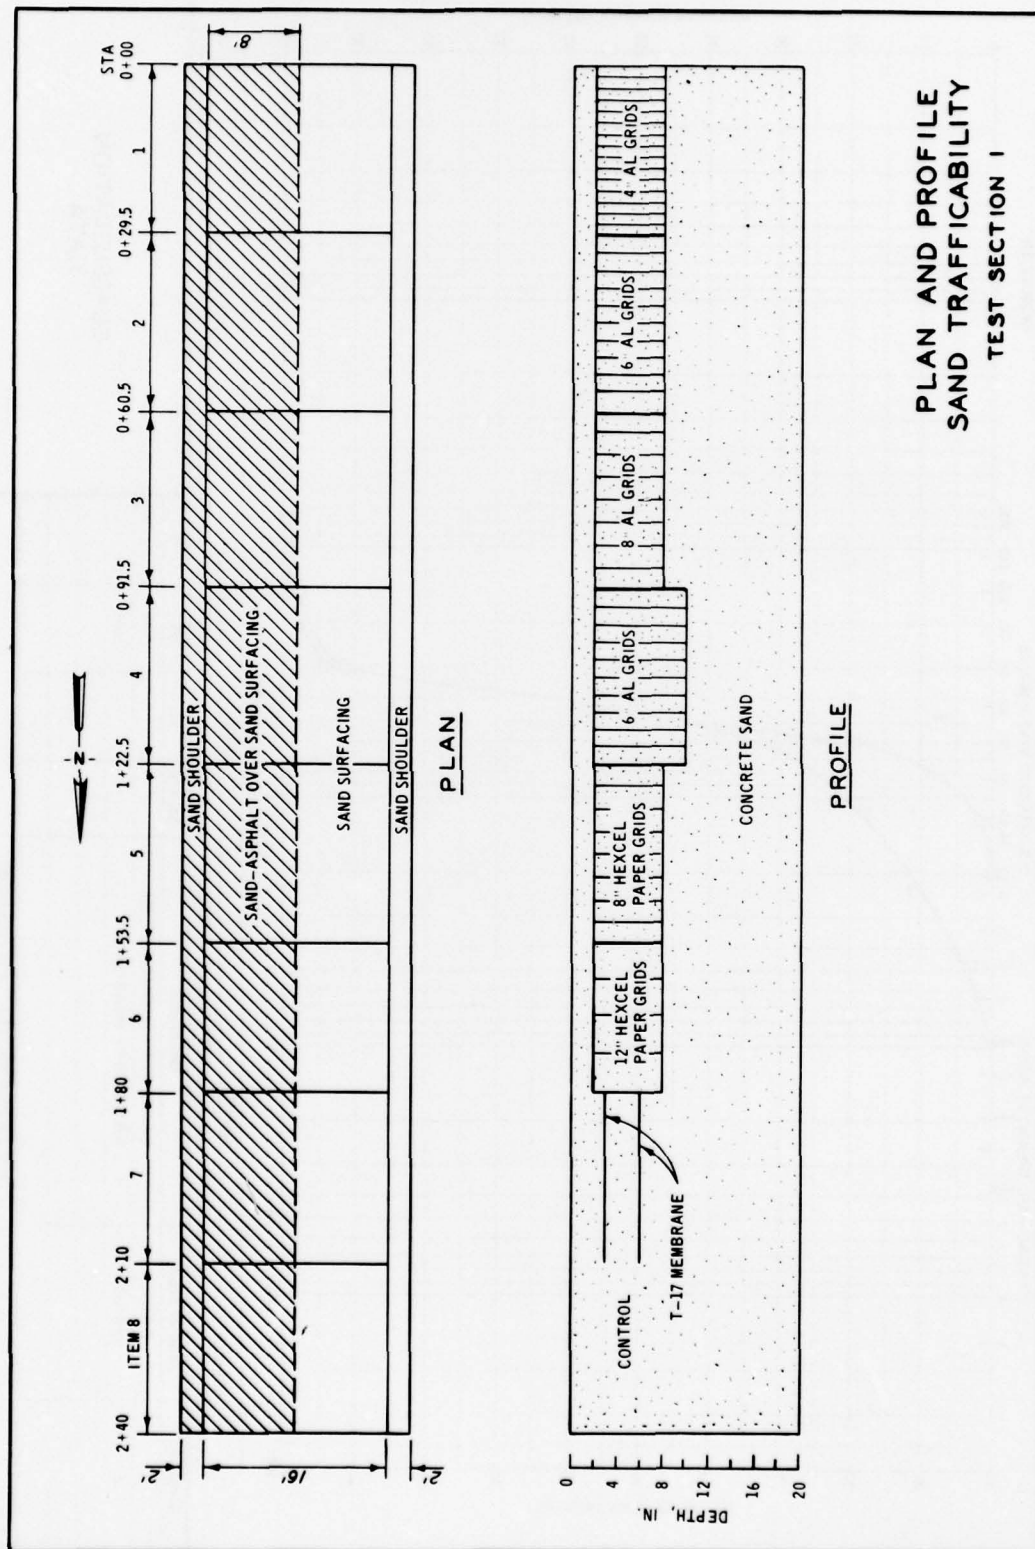
PLATE 2

PLAN AND PROFILE
SAND TRAFFICABILITY
TEST SECTION I

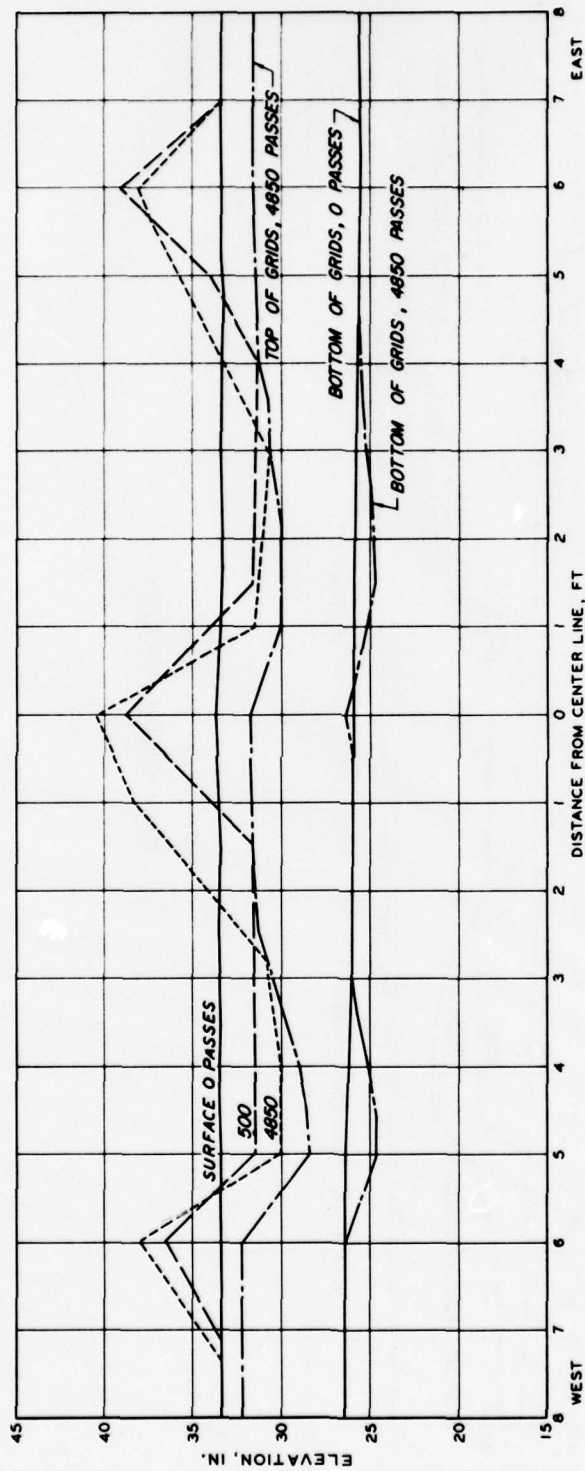
4-IN-SQUARE GRIDS, 6 IN. THICK

TYPICAL CROSS SECTION
TEST SECTION I
ITEM 1, STA 0+15

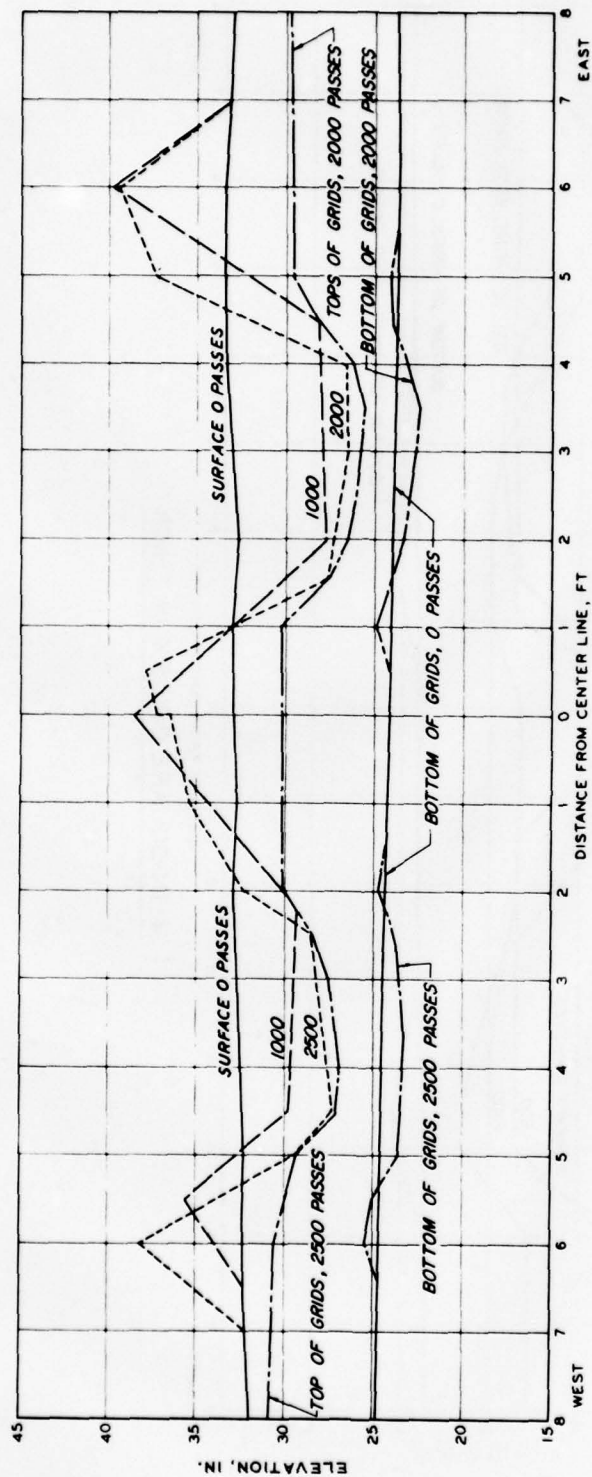
6-IN.-CUBIC GRIDS

TYPICAL CROSS SECTION
TEST SECTION I
ITEM 2, STA 0+37

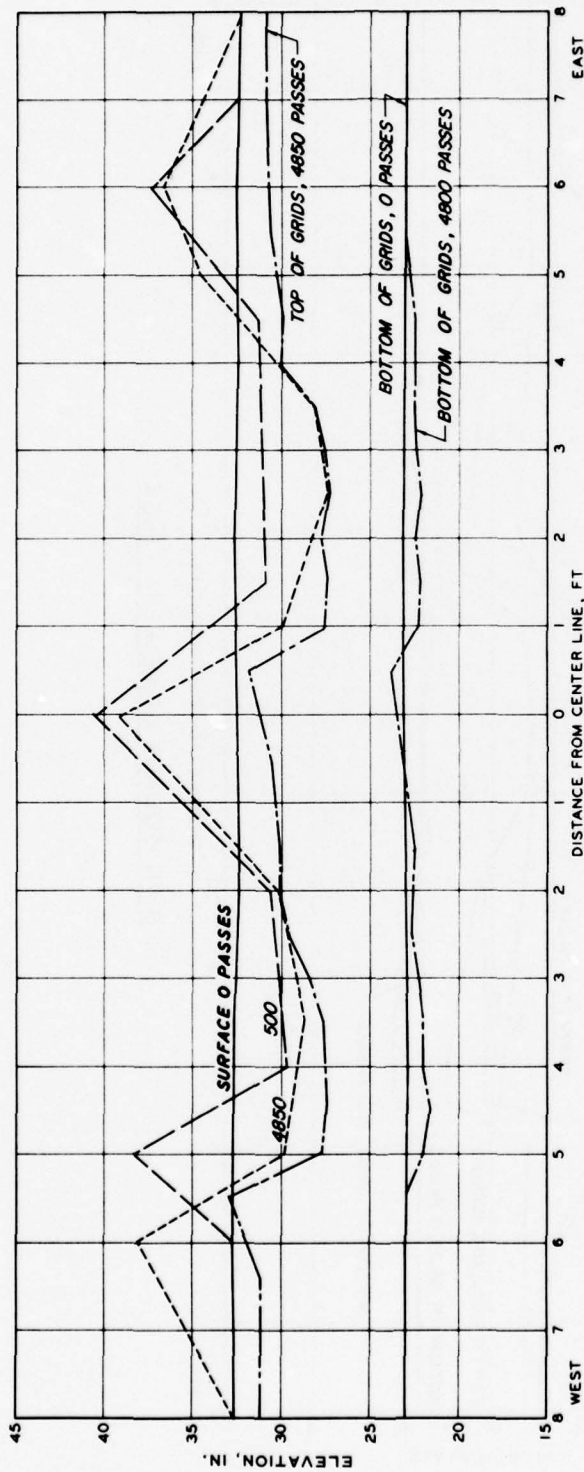
6-IN-SQUARE GRIDS, 8-IN. THICK

TYPICAL CROSS SECTION
TEST SECTION I
ITEM 4, STA 1+14

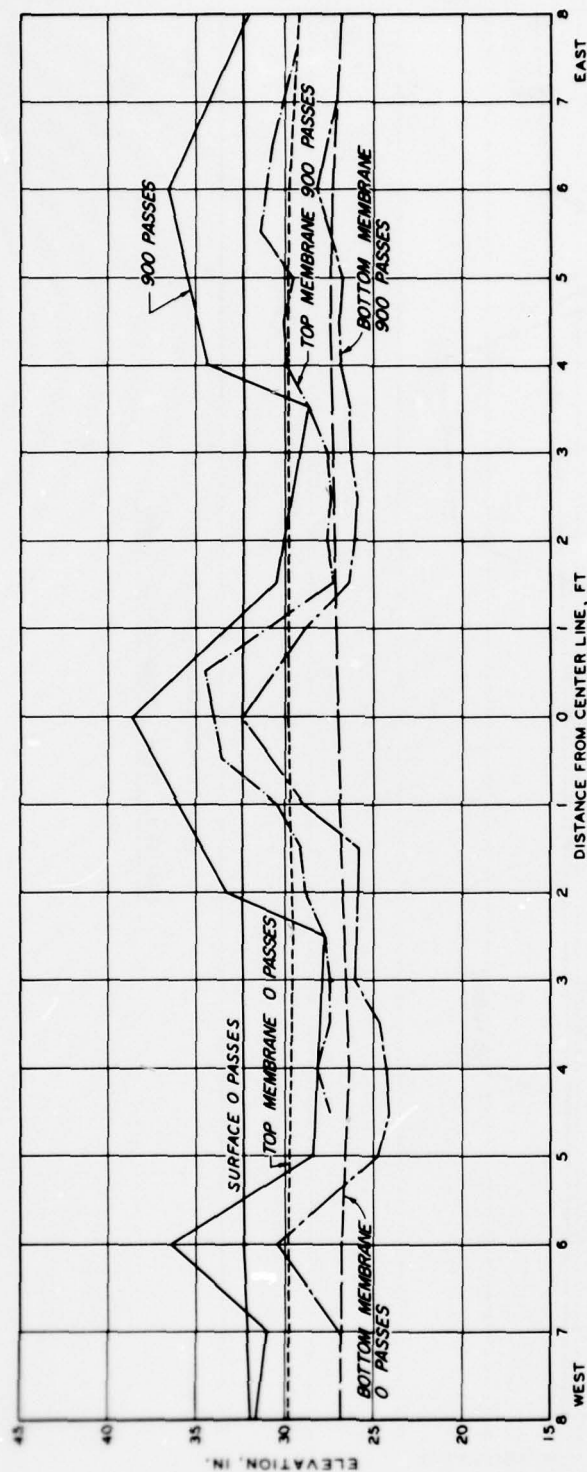
TWO-LAYER T-17 MEMBRANE

TYPICAL CROSS SECTION
TEST SECTION I
ITEM 7, STA 1+95

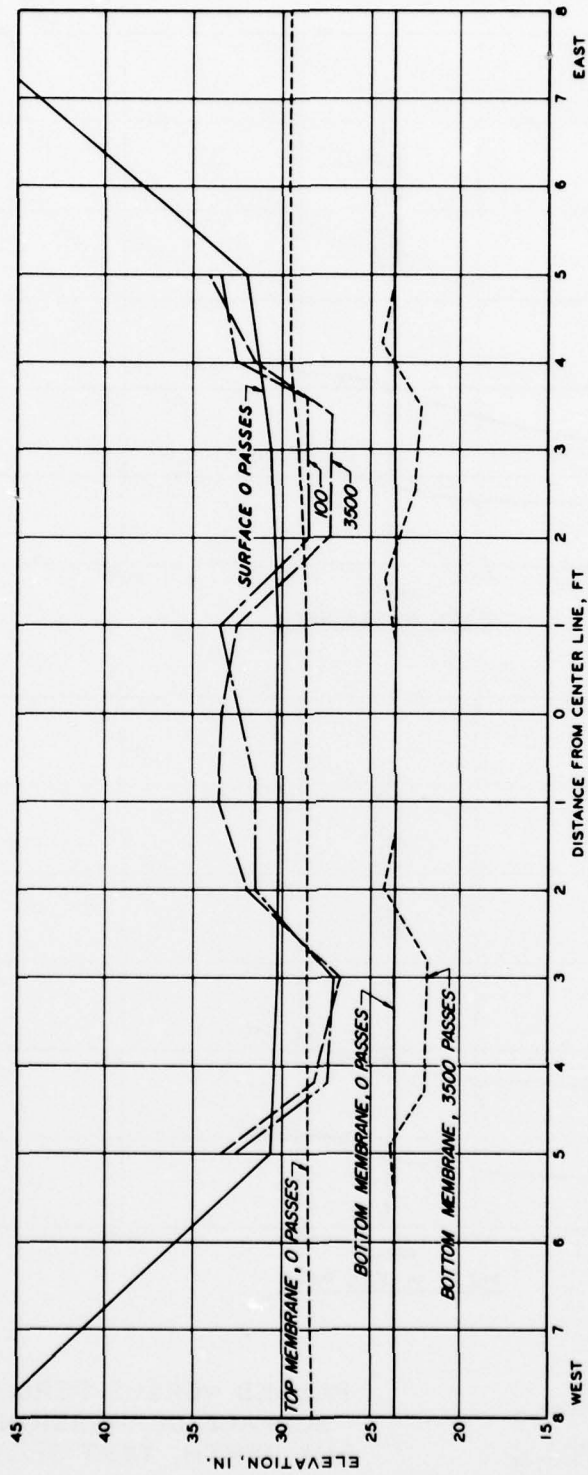
TWO-LAYER T-17 MEMBRANE

NOTE: PHOTO 60 SHOWS A CROSS SECTION VIEW OF THE TOP AND BOTTOM MEMBRANE POSITION AFTER 3500 PASSES.
